Re: Field Impact Insulation Class Testing Report  
Paramount Bay, Miami Florida

**Field Impact Insulation Class Testing Report  
Paramount Bay, Miami FL**

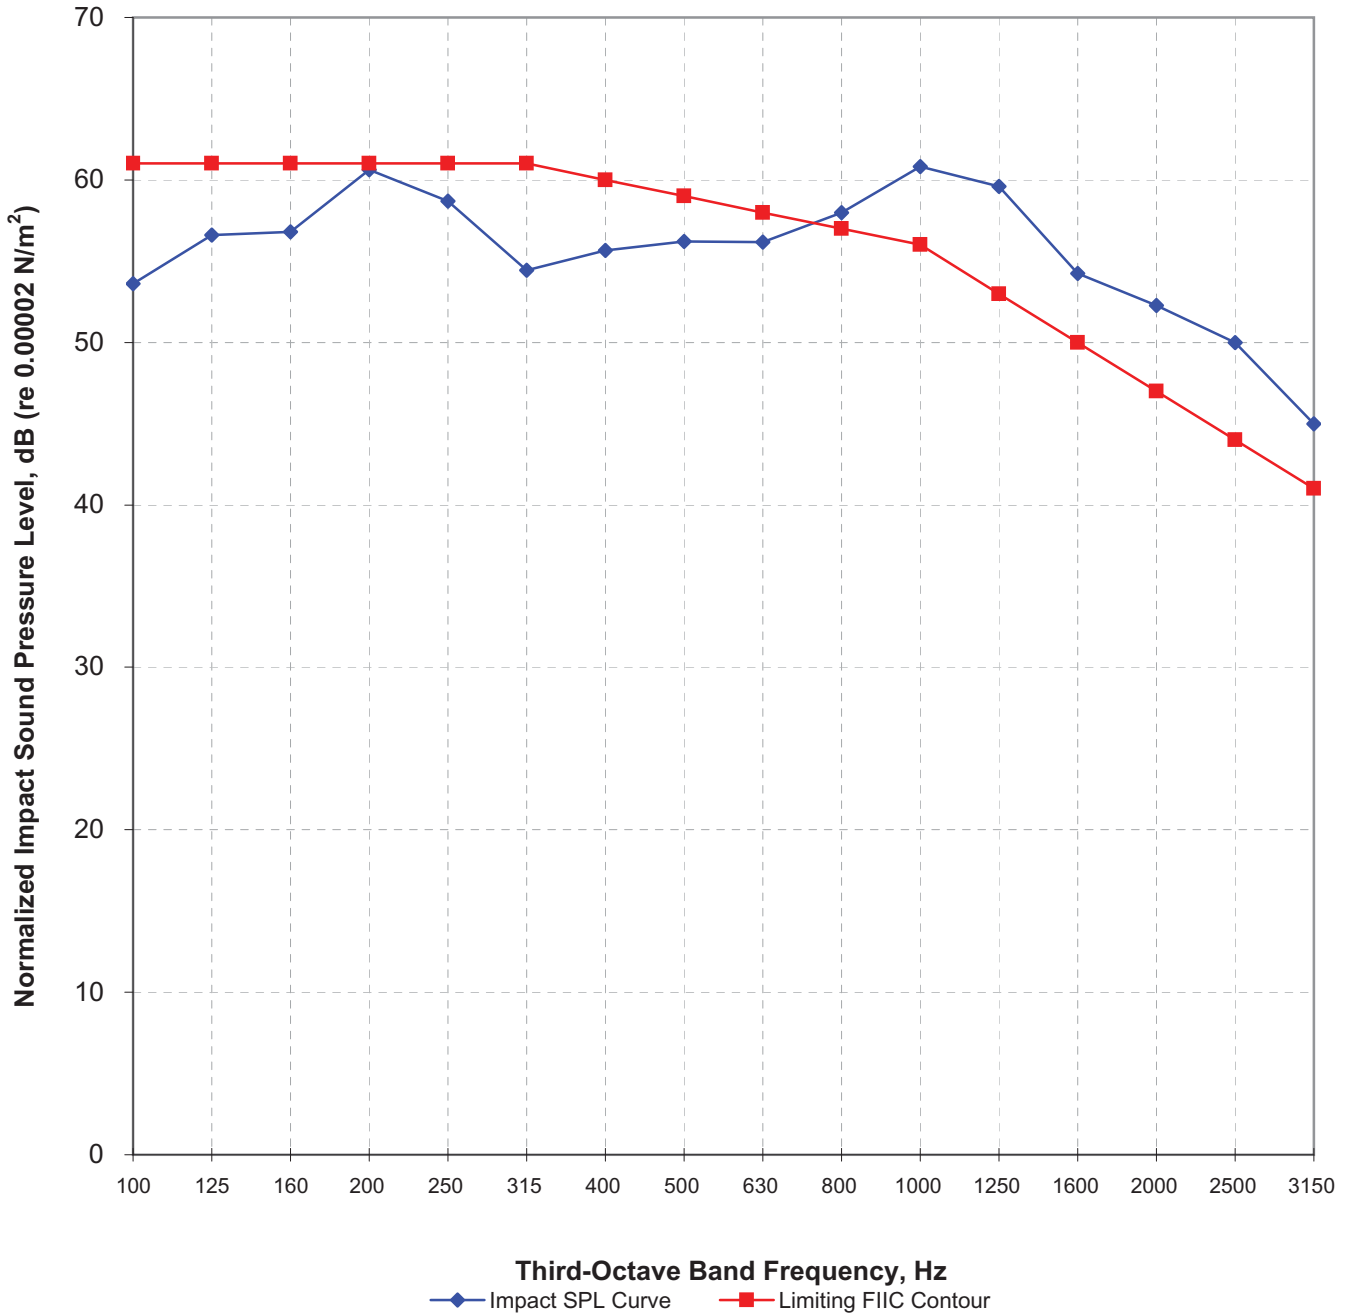
# Field Impact Insulation Class (FIIC)

Floor Assembly: 8" Concrete Slab

Test Specimen: 3/4" Marble on 5mm Cerazorb

FIIC: 51
